# **PROJECTS FINANCED FROM THE WORLD BANK LOAN completed from 2007 to 2009**

**Novi Sad 2010.**

PUBLIC WATER MANAGEMENT COMPANY "VODE  
VOJVODINE"

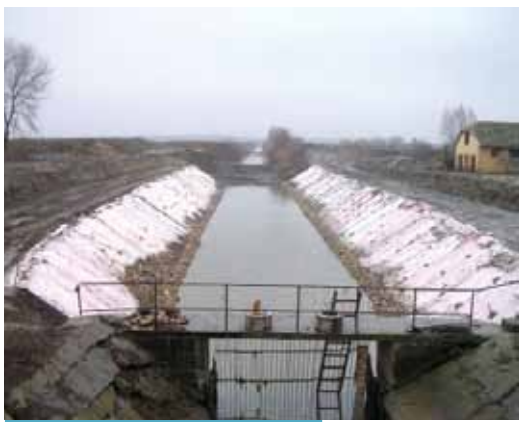
The main supply canal leading to the pumping station in Kupusina showed the consequences of erosion of the left and right banks in the length of around 70 m. The soil erosion threatened the structure on the bank. The erosion was caused by the fact that the bank was not secured

with a cover layer so that higher speed of water simply took the existing material away. Removal of the material is most emphasised around the inflow structure where oscillations of the water level are the highest.

Supply canal up to the Pumping Station Kupusina

The objective of this project is the rehabilitation of the supply canal and laying down of the canal cover on the threatened section. Covering of the canal banks prevented future erosions, which was the essence of rehabilitation works.

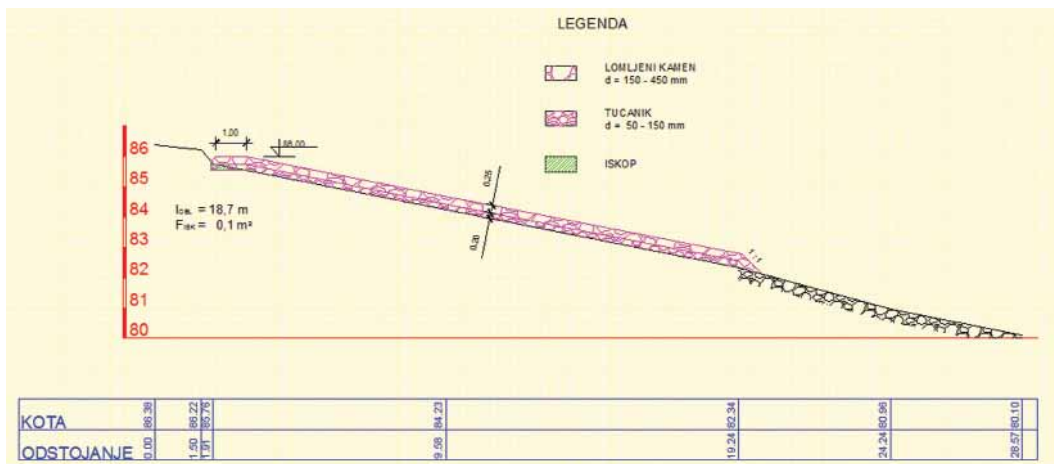
Regulation structures on the left bank of the Danube have the role to fortify and stabilise the banks in the vicinity of the first defence line dikes. The damages caused by ice have been registered on the embankment section from km 1431+060 to km 1430+740. The upper part of the embankment collapsed and slid into water, and dike foot that was at the distance of 30 m started caving in. The penetration of the first defence line dike would threaten the Kendjija-Karapandza area within the protected natural resort – Special Nature Resort “Gornje Podunavlje”, i.e. around 2,500 ha of agricultural and forest land and a large number of heads of game in our territory and settlements of Bezdán, Kolut, and Backi Breg with close to 8,300 inhabitants. Water would spread to the territory of Hungary since there are no border dikes.

The collided part of the embankment from km 1431+060 to km 1430+740 was rehabilitated with inserting of two-layer stone cover made of crushed gravel and stone, with creating of an embankment slant in 1:1.5 ratio. The layer made of crushed gravel that was 20 cm thick was installed on the prepared foundation and a slope (1:1.5) that was created, as well as a layer of roughly crushed stone ( $\varnothing$  150 – 450 mm) that was 25-45 cm thick. The edge that is 1 m wide was created on the upper part. It is going to be paved with cobblestones as well as the remaining part of newly created embankment slope.

Thanks to the works that were carried out the bank was protected and fortified, the process of caving in and closing up of the first defence line, which was located at the distance of 30 m from the bank, was stopped.

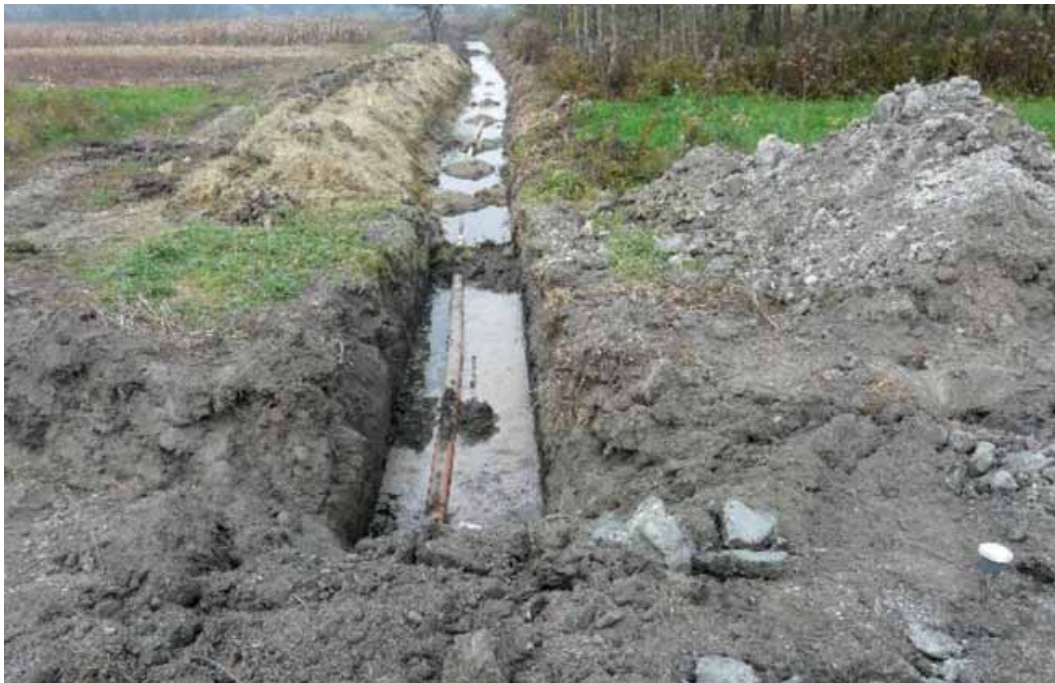
# dike at Mladenovo, Defence sector ogojevo, Technical section D.11.2 reloading wells (battery)

During high water levels of the Danube and flood defence activities, the occurrence of stale water and springs was registered in the undefended area beside the dike foot, at the dike section from km 39+450 to km 39+750.

Rehabilitation of the section from km 39+450 to km 39+750 of the dike was carried out by combining vertical and horizontal pipe drainage. Vertical drainage consists of self-discharging vertical wells (13 pieces) that are mutually connected with drainage pipes taking water into the Canal.

Horizontal pipe drainage enables reloading of soil surface layers and it consists of two arms, the overall length of which is 400 m. Accepted water is discharged into the drainage canal, which belongs to the land reclamation catchment area of Mladenovo.
